2021 Annual Report

Summerside Lake Environmental Services

Summerside Residents Association

February 3, 2022

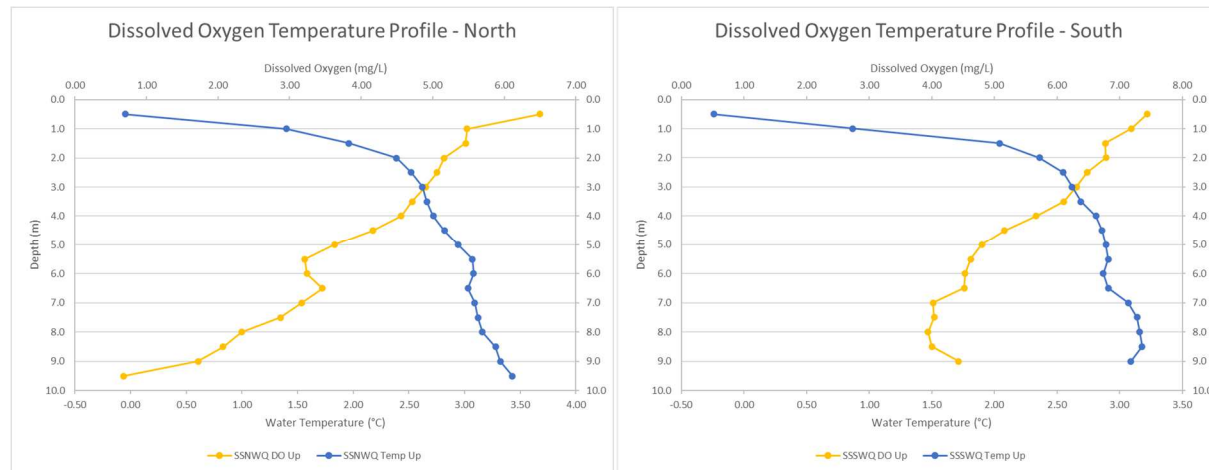
Figure 3. Dissolved oxygen and temperature profile for Summerside Lake at the north and south sites, January 29, 2021.

As expected, the lowest water temperatures were less than 0.0°C at the ice-water interface, and the highest at the bottom, measuring 3.4°C (Appendix A, Table A1-A2, Figure 3). The rate of temperature increase was highest within the first 2.0 to 2.5 m (thermocline), and then the rate declined.

At the north site, the DO was 6.5 mg/L at the surface, was below 5.0 mg/L at a depth of approximately 3 m, and was below 1.0 mg/L at a depth of 9.5 m (Figure 3). At the south site, the DO was 7.4 mg/L near the surface, was below 5.0 mg/L at a depth of approximately 5 m and remained at approximately 4.0 mg/L near the bottom at 9.0 m. The short-term (acute) DO guideline for the protection of freshwater aquatic life is 5.0 mg/L (EQGASW 2018). For certain times of the year and some invertebrates, 8.3 mg/L is considered a long-term guideline (or chronic guideline).

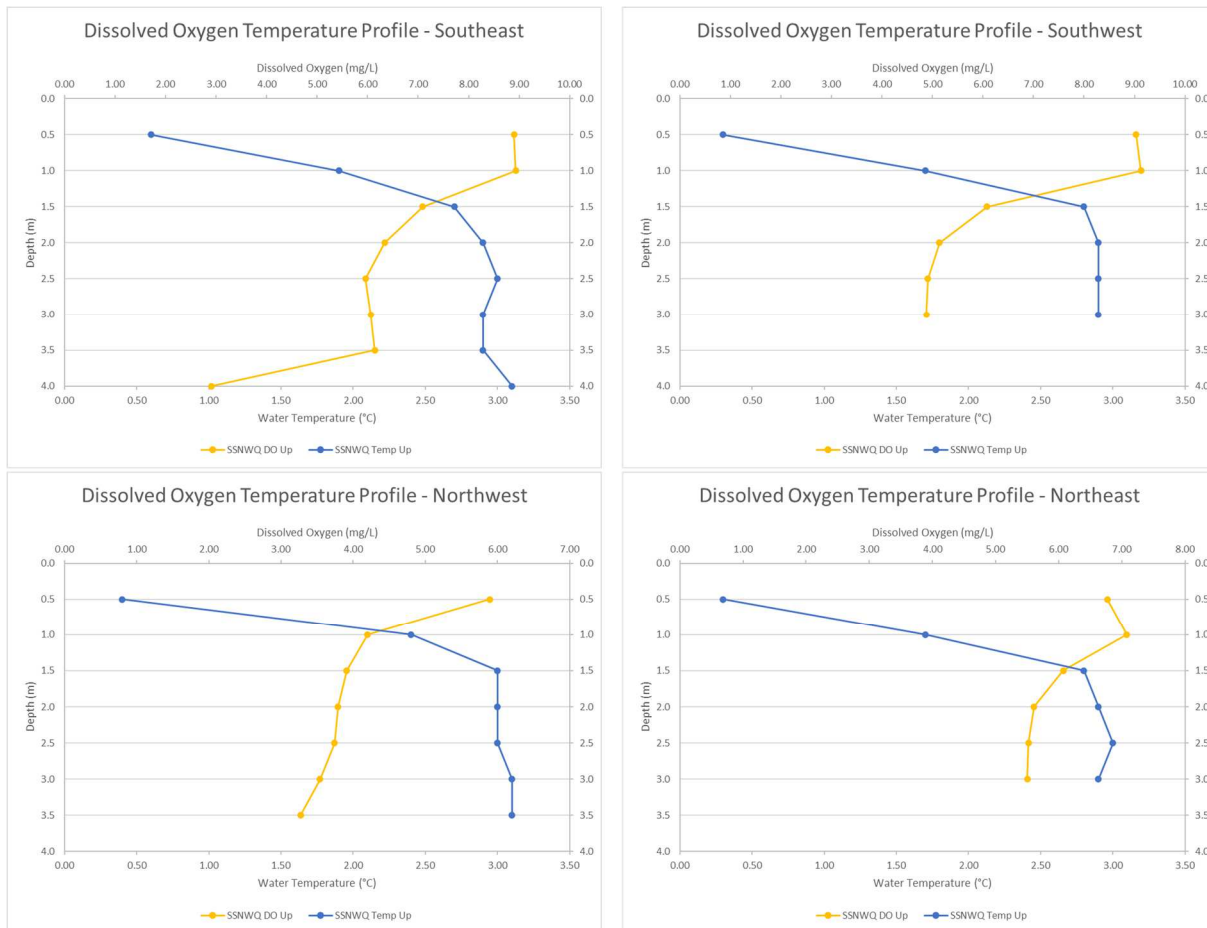
Figure 4. Dissolved oxygen and temperature profile for Summerside Lake at the southeast, southwest, northwest, and northeast sites, March 10, 2021.

The lowest DO concentration was measured at the southeast site (2.91 mg/L) near the bottom of the lakebed at 4.0 m (Appendix A, Table A3; Figure 4). The highest DO concentration was at the southwest site (9.70 mg/L) at 0.5 m, but have been elevated from augering the hole through the ice as concentrations were typically approximately 9.0 mg/L at the south sites (Appendix A, Table A4; Figure 4). Overall, the northwest corner of the lake had the lowest DO.

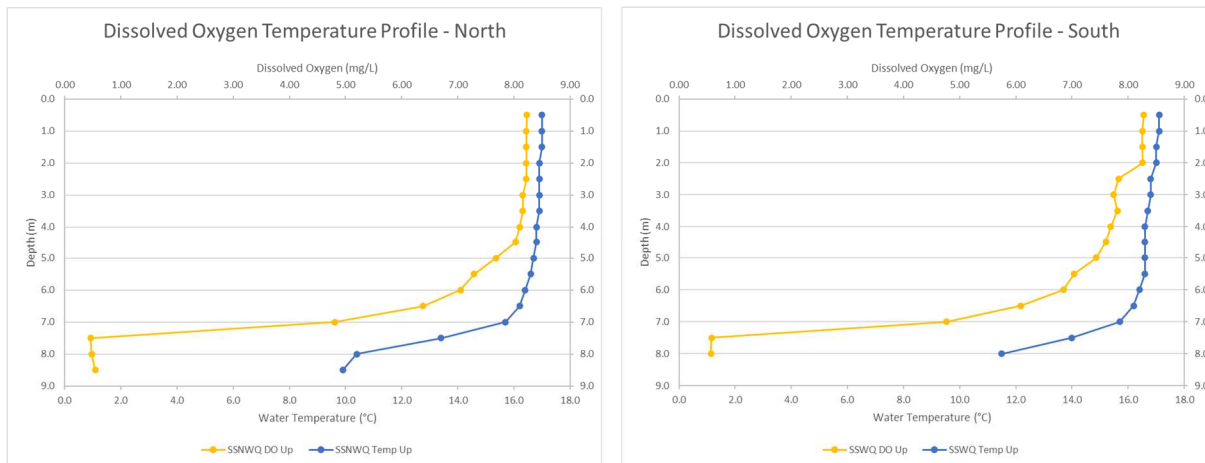
Figure 5. Dissolved oxygen and temperature profile for Summerside Lake at the north and south sites, August 26, 2021.

The DO again declined with depth, like the under-ice conditions. The highest DO concentrations were above 8.0 mg/L, due to wind and wave action (Appendix A, Tables A7-A8; Figure 5). The lowest concentrations were measured at 9 m depth (near bottom) at the north site (0.48 mg/L) and 8 m depth in the south (0.57 mg/L). DO concentrations also decreased at a higher rate below 6.0 and 6.5 m, but were below 5.0 mg/L at a depth of 7.0 m.

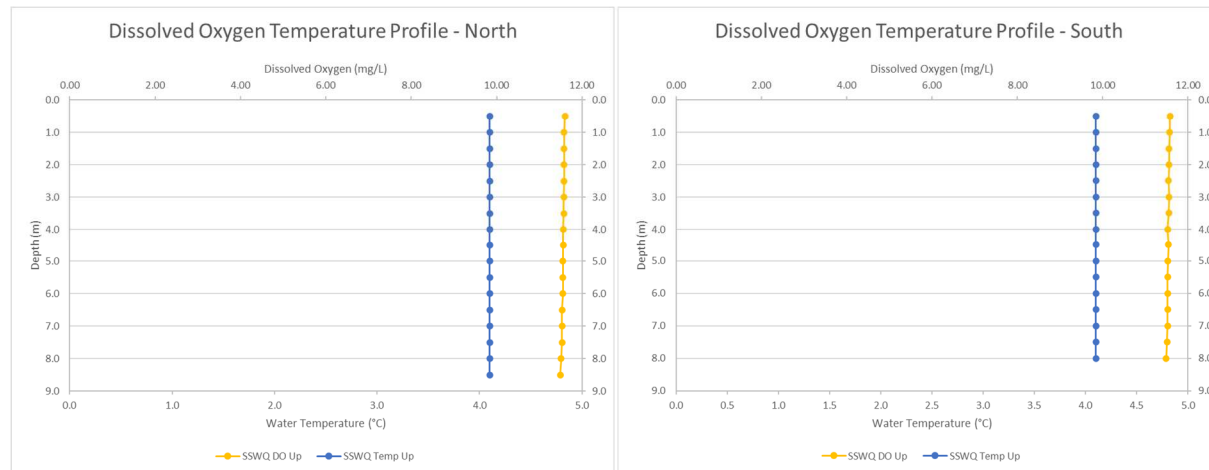
Figure 6. Dissolved oxygen and temperature profile for Summerside Lake at north and south sites, November 3, 2021.

The temperatures at both sites remained consistent with depth. The temperature at the north site ranged from 4.0°C-4.1°C and 4.1-4.2°C at the south site (Appendix A, Table A9-A10). The straight lines in the temperature and DO profiles for both sites (Figure 6) indicate the lake was well mixed due to fall turnover and aeration. The DO concentrations ranged between 11.49 mg/L and 11.60 mg/L at the north site and between 11.46 mg/L and 11.58 mg/L at the south site (Appendix A, Table A9-A10; Figure 6). Compared to the DO profiles measured earlier in 2021, November had the most consistent measurements throughout the water column.

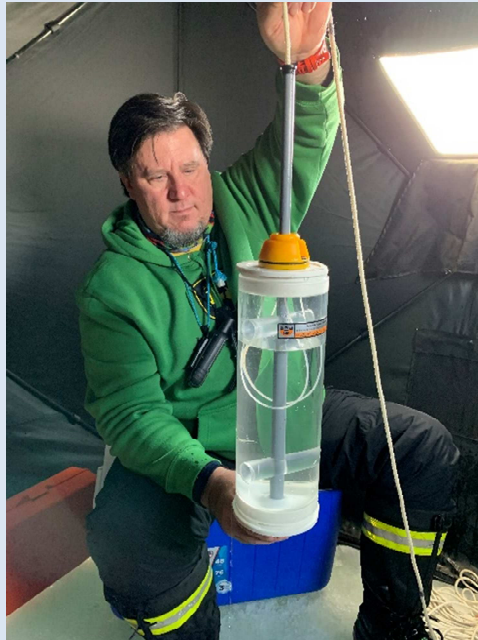
| Description: Collecting under-ice water sample using a Kemmerer sampler |

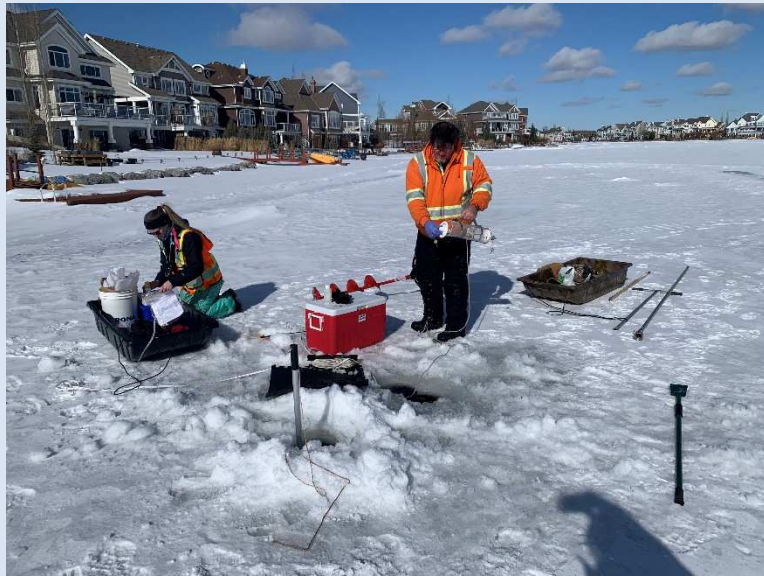
| Photo 3 |

| Description: Collecting sediment cores and water samples for water quality monitoring |

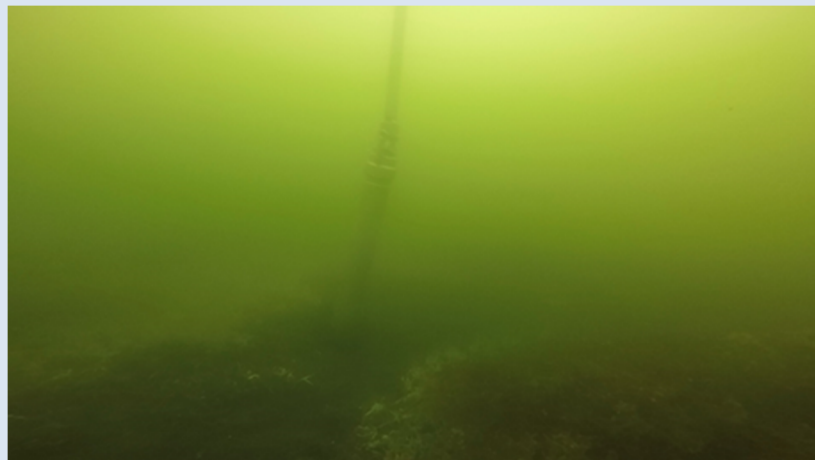
| Photo 4 |

| Description: Underwater view of sediment corer collecting a sample. |

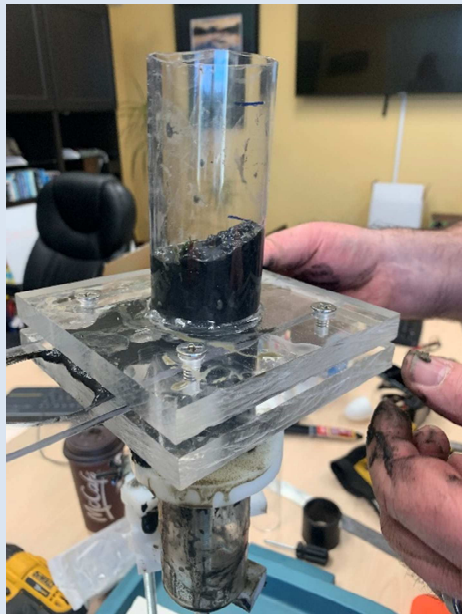
| Photo 6 |

| Description: Sediment core being divided into 5 cm increments for phosphorus analysis. |

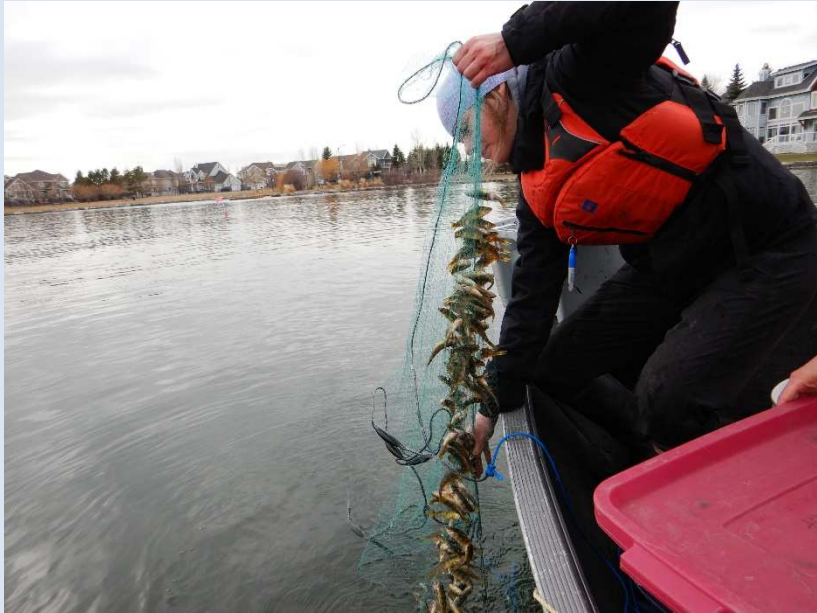
| <p>Description: Removal of Yellow Perch using gill nets</p> | |

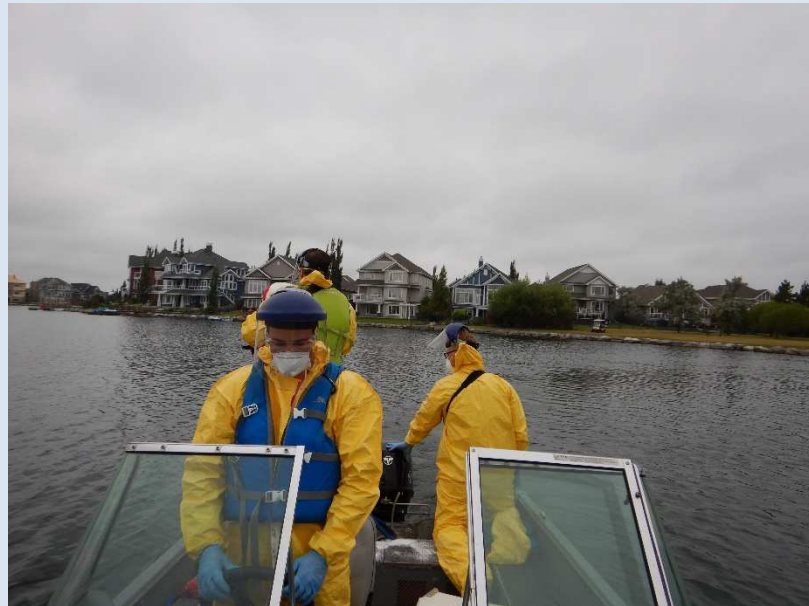
| Description: Treating Lake Summerside with hydrogen peroxide to combat undesirable algae growth |

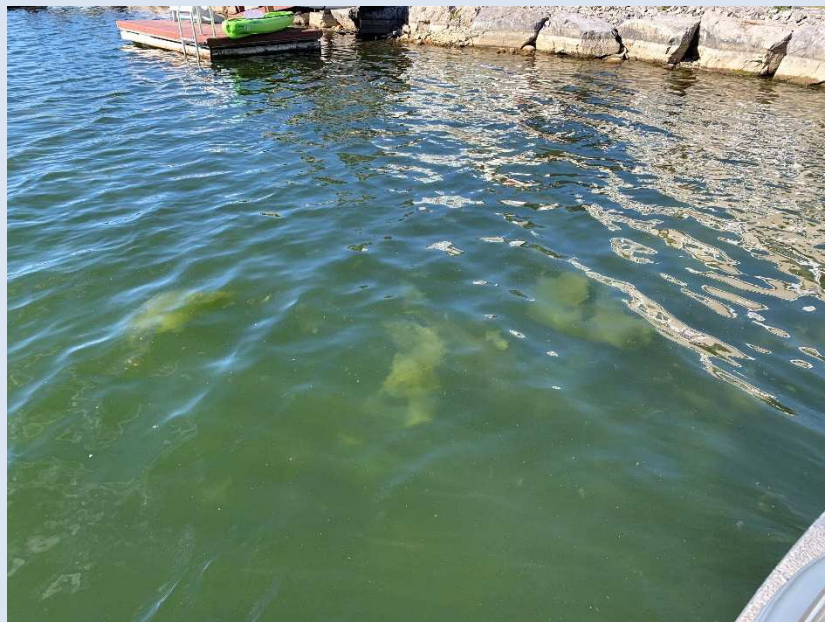
| Photo 10 |

| Description: Algal masses rising to the top after being treated by hydrogen peroxide |

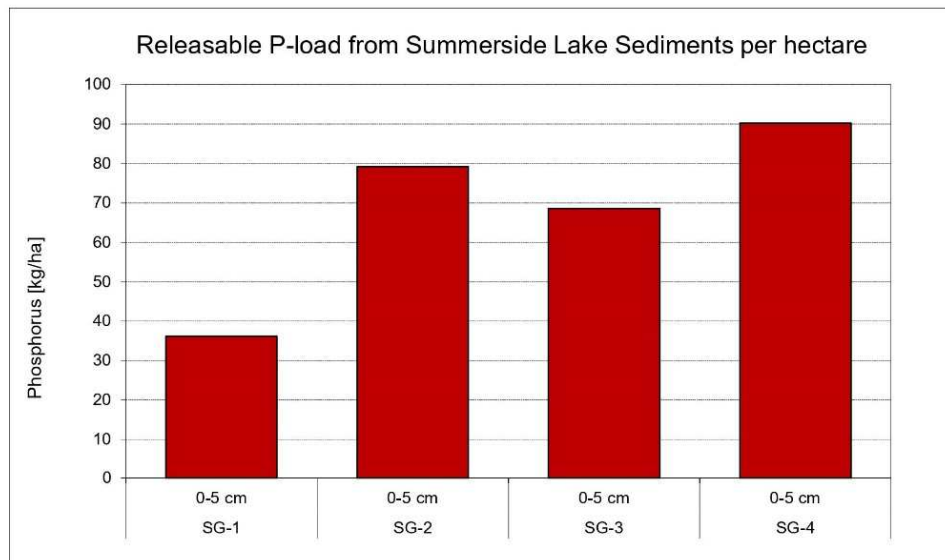
Figure 3. Total potential phosphorus load from Summerside Lake sediments per hectare (10,000 m²)

Taken over the whole surface area of the lake, our data suggest that that a maximum of 274 kg phosphorus could be released either from sediment pore water or under reduced conditions. This quantity does not however include aluminium bound P which could potentially also be increased as pH values increase (e.g. during phytoplankton blooms), at least in the shallower areas of the lake. The pool of aluminium bound P in the top 5 cm of the lake is calculated to be 83.9 kg for the whole lake area (Table 3).

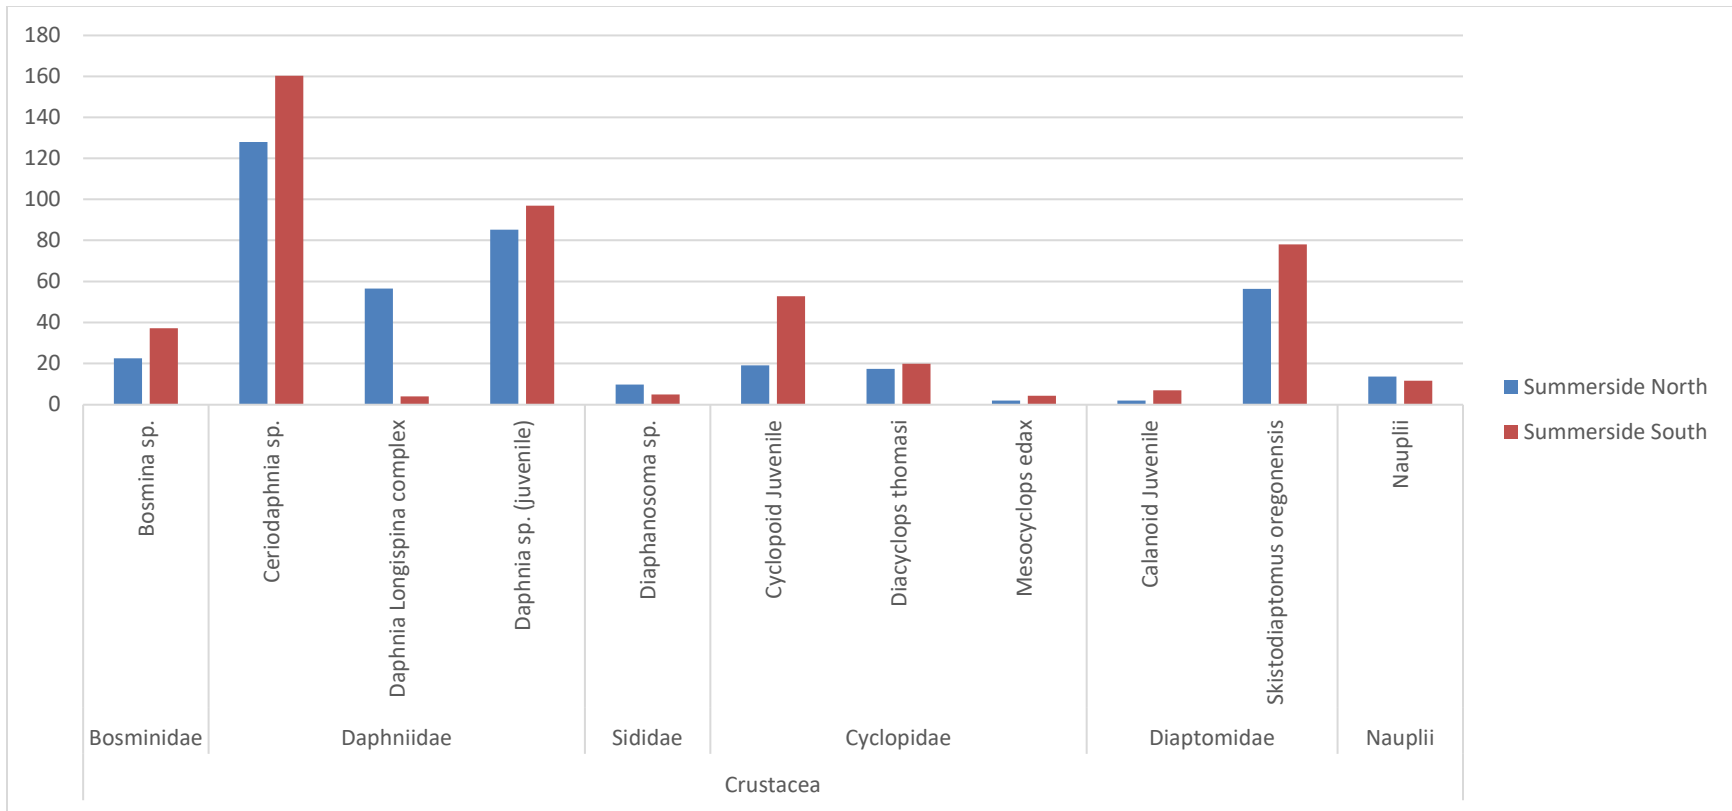
Figure E4. Comparison of the overall Crustacea zooplankton biomass for the Summerside north and south sites, August 26, 2021.
