## **2022 Annual Report**

Summerside Lake Environmental Services

Summerside Residents Association

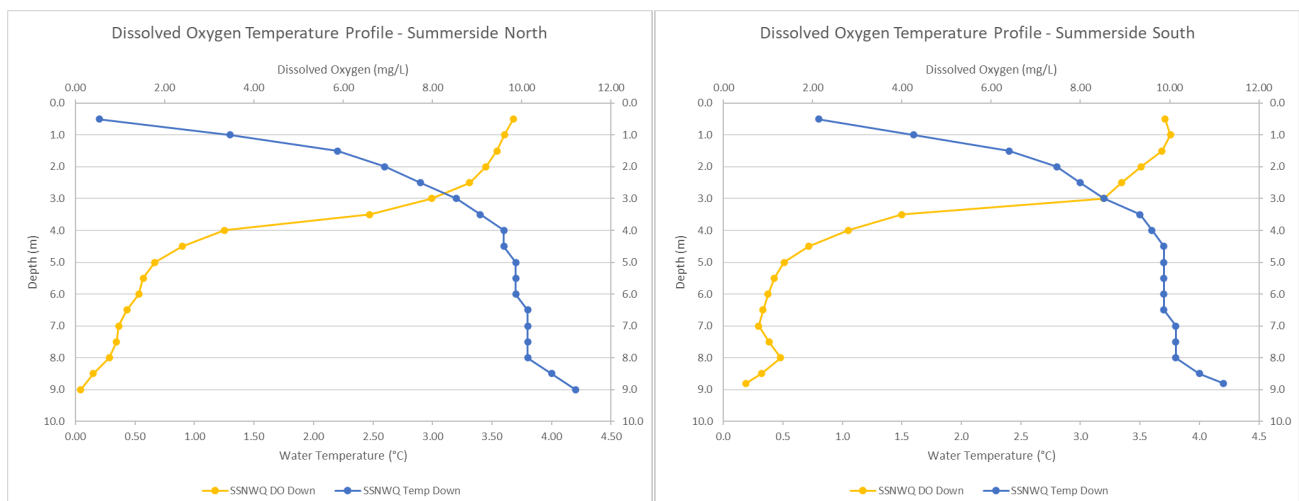
Figure 3. Dissolved oxygen and temperature profile for Summerside Lake at the north and south sites, February 18, 2022.

As expected, the lowest water temperatures were less than 1.0°C at the ice-water interface, and the highest at the bottom, measuring 4.4°C (Appendix A, Table A1 and A2, Figure 3). The rate of temperature increase was highest within the first 1.5 to 4.0 m (thermocline), and then the rate declined.

The DO declined with depth (Appendix A, Table A1 and A2). At the north site, the DO was 9.8 mg/L at the surface, was below 5.0 mg/L at a depth of approximately 3.75 m and was below 1.0 mg/L at a depth of 7.0 m (Figure 3). At the south site, the DO was 9.9 mg/L near the surface, was below 5.0 mg/L at a depth of approximately 3.25 m and below 1.0 mg/L at a depth of 6.0 m. The short-term (acute) DO guideline for the protection of freshwater aquatic life is 5.0 mg/L (EQGASW 2018). For certain times of the year and some invertebrates, 8.3 mg/L is considered a long-term guideline (or chronic guideline).

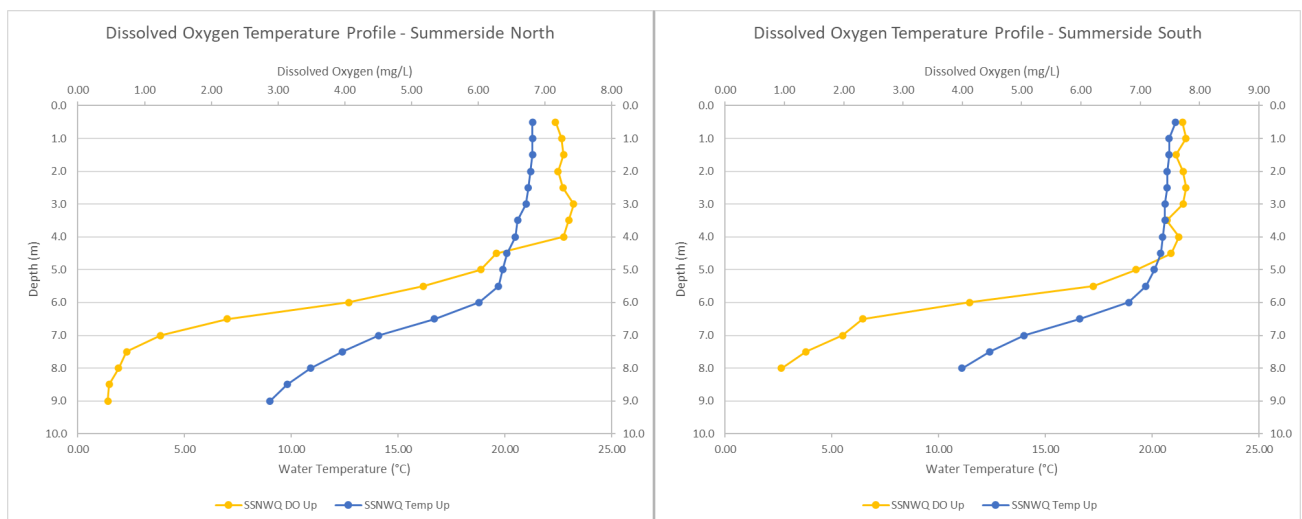
Figure 4. Dissolved oxygen and temperature profile for Summerside Lake at the north and south sites, August 9, 2022.

Water temperatures at both sites decreased with depth in contrast to measurements collected during winter ice conditions. The coldest location at the north site was at a depth of 9 m and was 9.0°C (Appendix A, Table A3; Figure 4). The coldest location at the south site was at a depth of 8 m and was 10.7°C (Appendix A, Table A4). The maximum surface temperature measured was 21.3 °C measured at 0.5 m depth (Appendix A, Table A3 and A4). The thermocline was located between 5.5 and 6.0 m.

The DO again declined with depth, like the under-ice conditions. The highest DO concentrations were approximately 7.7 mg/L, due to wind and wave action (Appendix A, Tables A3 and A4; Figure 4). The lowest concentrations were measured at 9 m depth (near bottom) at the north site (0.45 mg/L) and 8 m depth in the south (0.95 mg/L). DO concentrations also decreased at a higher rate below 5.5 and 6.5 m, but were below 5.0 mg/L at a depth of approximately 5.75 m.

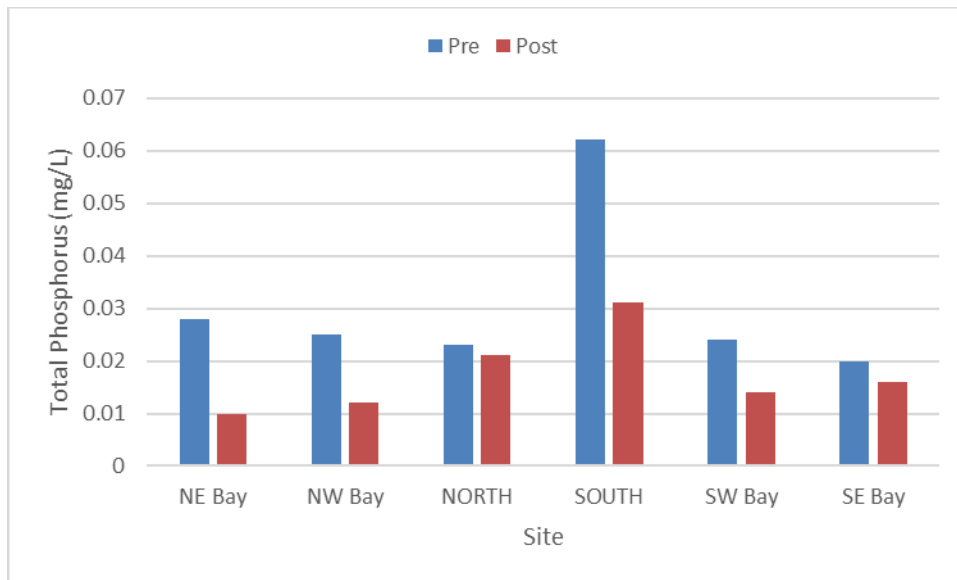
Figure 5. Total phosphorus concentrations (mg/L) pre- and post-treatment, 2022.

A reduction in the total available phosphorus was observed between the pre- and post-alum treatment at all sites. The reduction was more than half in several cases; however, the reduction was less pronounced at one shallow site (southeast bay) and one deep site (north) (Figure 5; Appendix B, Table B1).

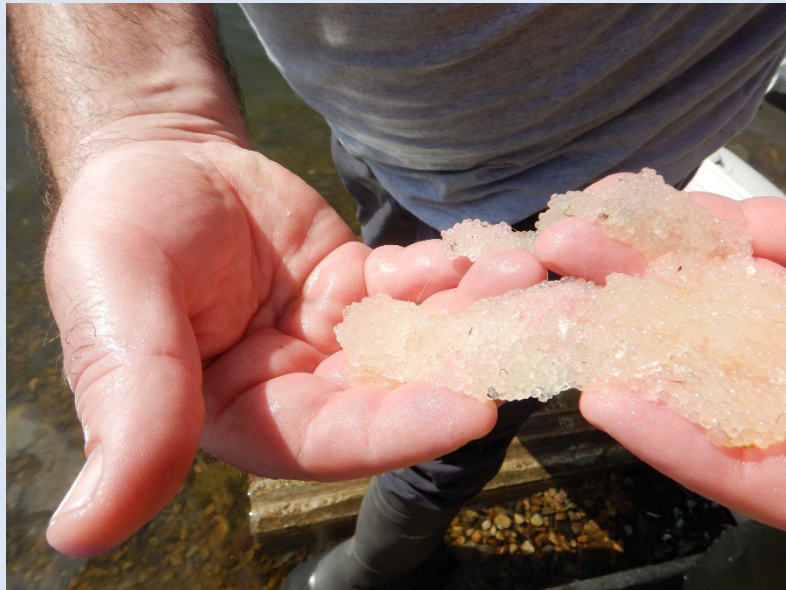
<b>Photo 1</b>
<b>Date:</b> 2 May 2022
<b>Location of Photo:</b> Summerside Lake
<b>Photo Direction:</b> N/A
<b>Description:</b> Yellow Perch egg mass collected from boat launch.

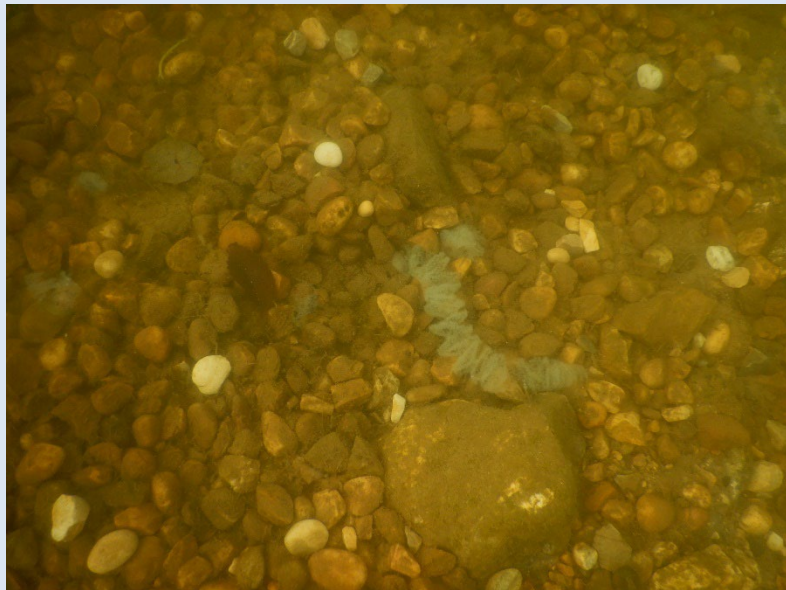
<b>Photo 2</b>
<b>Date:</b> 2 May 2022
<b>Location of Photo:</b> Summerside Lake
<b>Photo Direction:</b> N/A
<b>Description:</b> Yellow Perch egg "ribbons" in situ near boat launch.

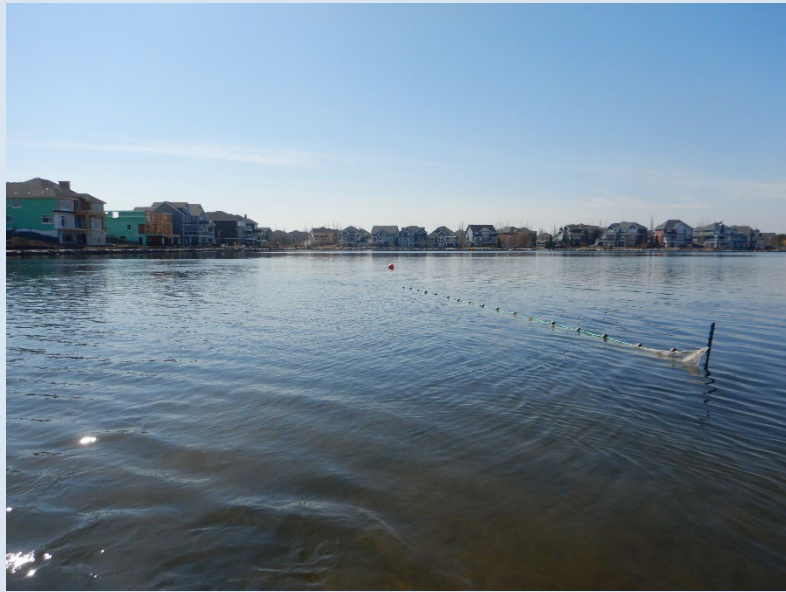
<b>Photo 3</b>
<b>Date:</b> 3 May 2022
<b>Location of Photo:</b> Summerside Lake
<b>Photo Direction:</b> West
<b>Description:</b> Hoop net set on the south side of the beach.

Two hoop nets were set on both ends of the beach. Each hoop net was 3.8 m long x 0.8 m diameter and consisted of three compartments with a terminal cod end. The compartments were separated by five rings 0.8 m apart, with throat openings of 0.2 m. The outer frame was enclosed in 6 mm mesh and there were zippers between hoops to facilitate fish removal. The hoop net also had two wings (7.6 m long x 1.2 m wide; 13 mm mesh) with a lead line along bottom and floats along top.

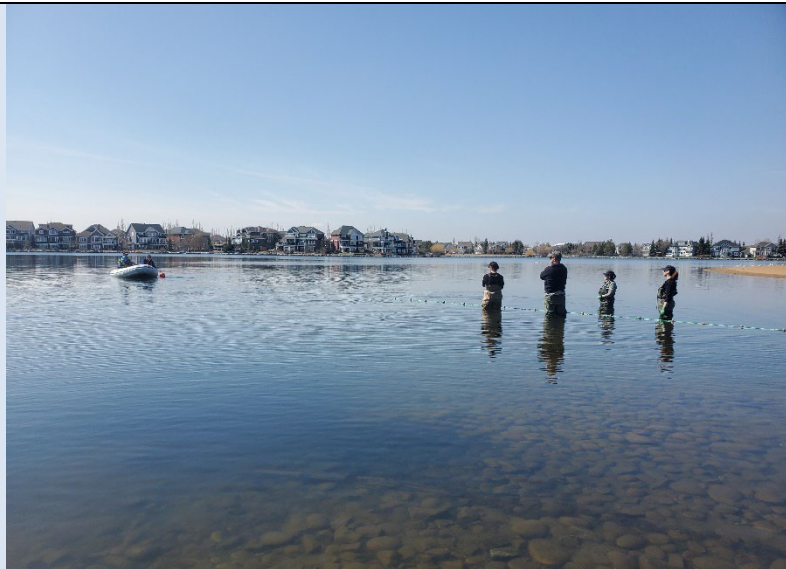
<b>Photo 4</b>
<b>Date:</b> 3 May 2022
<b>Location of Photo:</b> Summerside Lake
<b>Photo Direction:</b> Northwest
<b>Description:</b> Retrieving hoop net set south of beach.

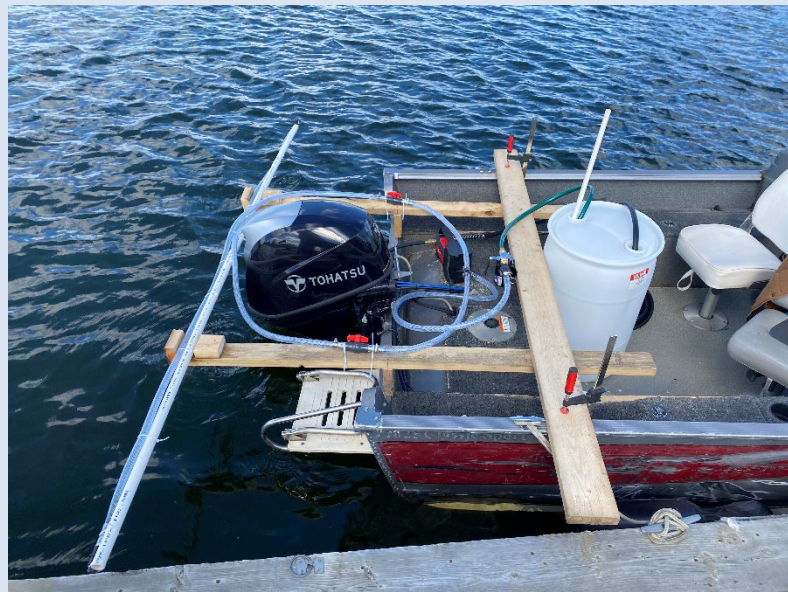
<b>Photo 5</b>
<b>Date:</b> 30 May 2022
<b>Location of Photo:</b> Summerside Lake
<b>Photo Direction:</b> N/A
<b>Description:</b> Boat configured for treating shoreline with Floc N Lock alum treatment.

On 30 May 2022, Flocc N'Lock (an alum-based treatment) was applied to the entire shoreline of Lake Summerside. The product is alum-based and acts to bind phosphate to the top of the sediment layer, thus removing or “locking” phosphorus from the system. Water samples were collected for analysis pre- and post-alum treatment (May 25 and June 2, 2022, respectively) to determine changes in the phosphorus concentrations. Water samples were collected from the bottom near the substrate water interface at six locations, including four shallow sites (bays) and two deep sites. Low level detection limits were requested for dissolved and total phosphorus, but unfortunately, low level dissolved phosphorus results were not provided for the pre-treatment samples.

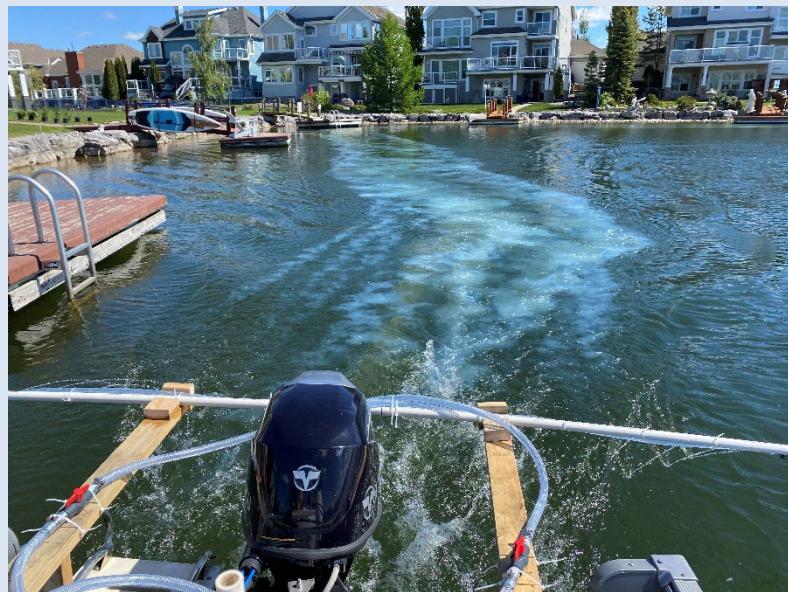
<b>Photo 6</b>
<b>Date:</b> 30 May 2022
<b>Location of Photo:</b> Summerside Lake
<b>Photo Direction:</b> N/A
<b>Description:</b> Application of Floc N Lock alum treatment.
