# 2024 Annual Summary Report

Fisheries and Water Quality

Summerside Residents Association

23 January 2025

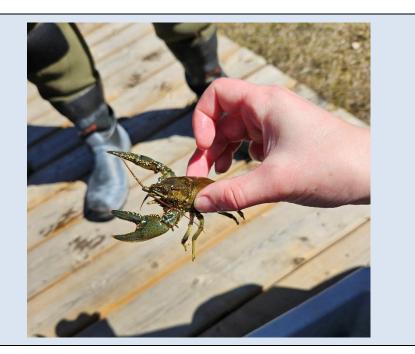
Photo 3	
Date: 10 May 2024	
Location of Photo:	
East side of Summerside Lake	
Photo Direction:	
N/A	
Description:	
Fish captured in one hoop net.

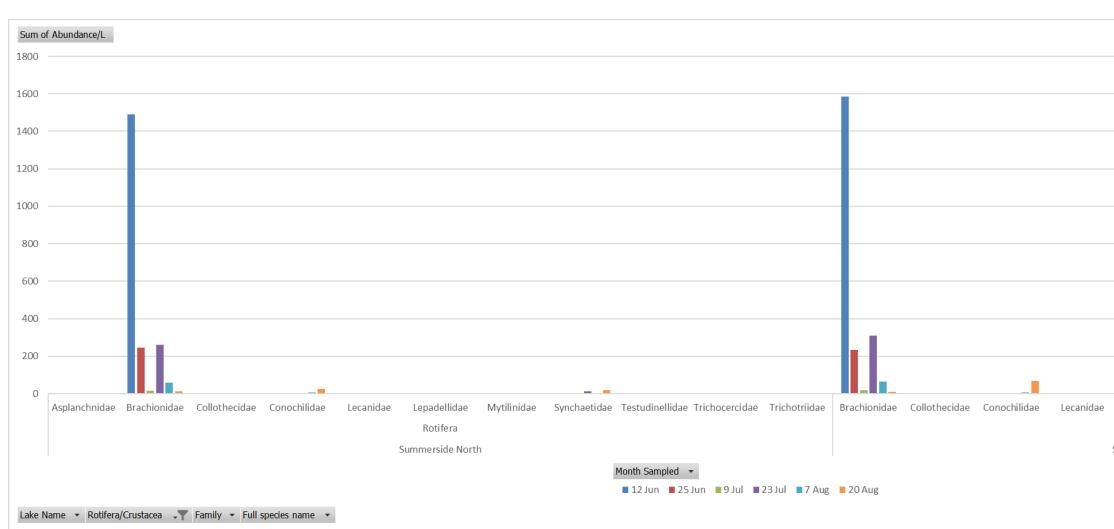
Figure 9. Comparison of the overall Rotifera zooplankton abundance for the Summerside Lake north and south sites, 2024.

Zooplankton abundance and biomass analysis were conducted on samples collected during the summer from the north and south deep sites in Summerside Lake. A high-level comparison of abundance of zooplankton, identified as either subphylum Crustacea or phylum Rotifera, is presented in Table 8 below. The abundance of Rotifera and Crustacea dropped by the end of June, notably by 9 July 2024. This decrease in abundance is opposite to the increase of the Chlorophyll-a concentration (phytoplankton biomass) and temperature observed in July (Table 7, Figure 8). The peroxide application on June 18 preceded the decrease in zooplankton abundance and may have contributed to the decline, but the correlation cannot be confirmed.
